**TURNOVER INSPECTION
for
COPPER COVE PRESERVE**

**Prepared For and
Submitted To:**

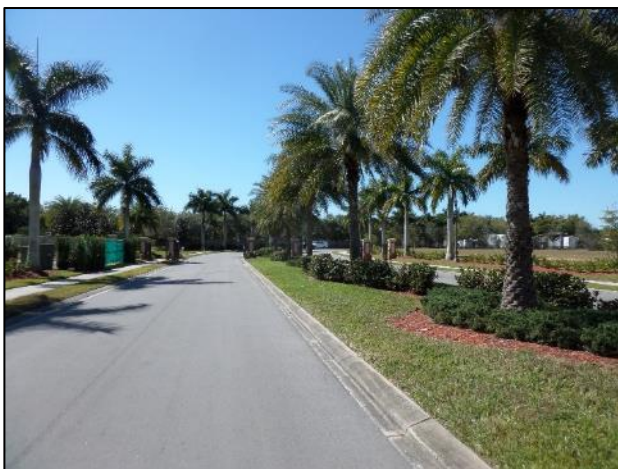
Typical asphalt surface, note water stained gutters-south area

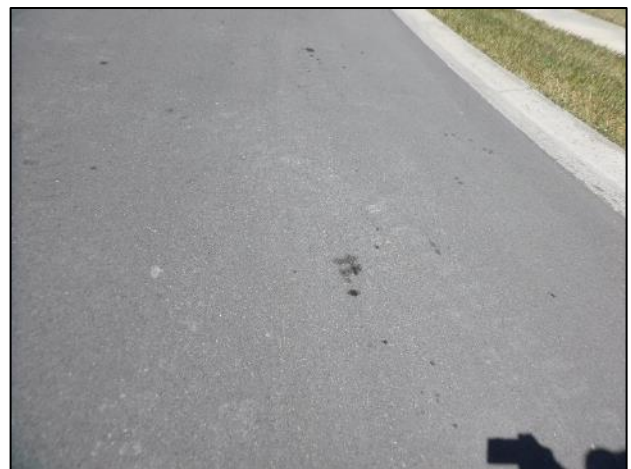
Stains in roadway surface – south area

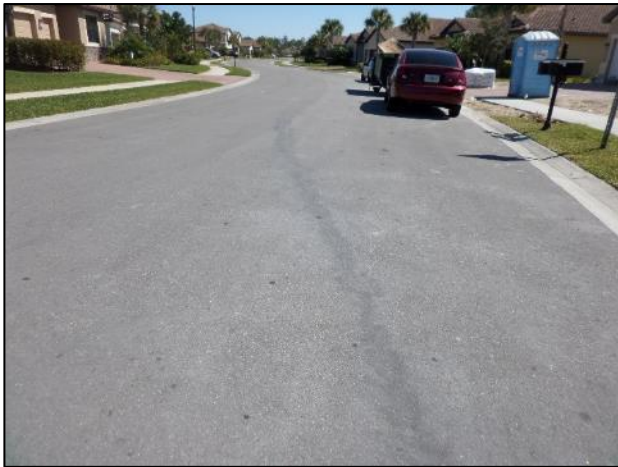
Stains in roadway surface – south area

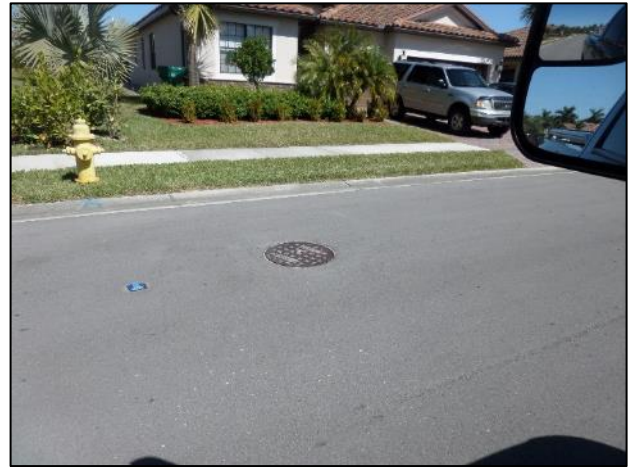
Water stained gutter – south area

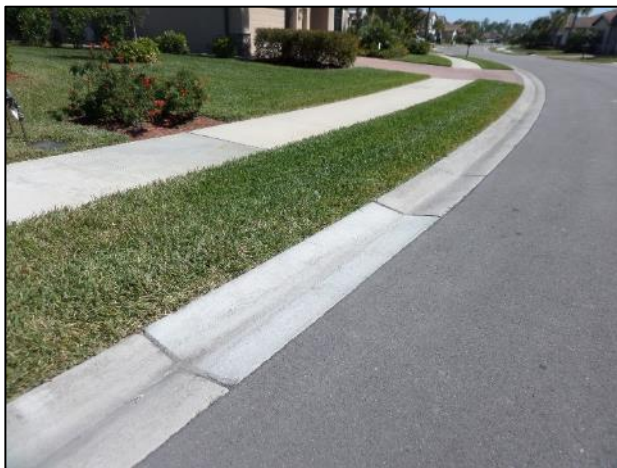
Evidence of repair of concrete gutter – south area

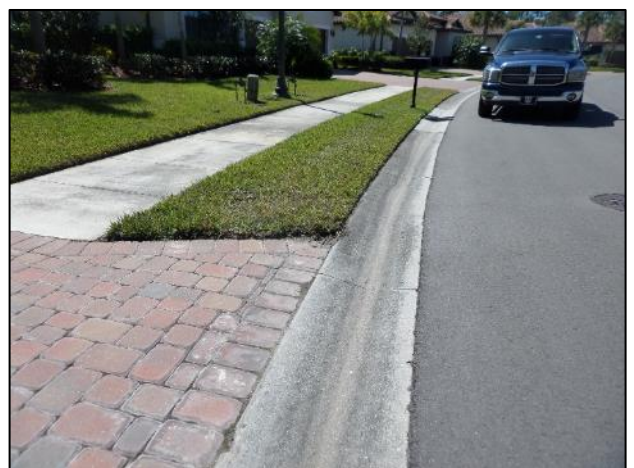
Water stains/chips at gutter – south area

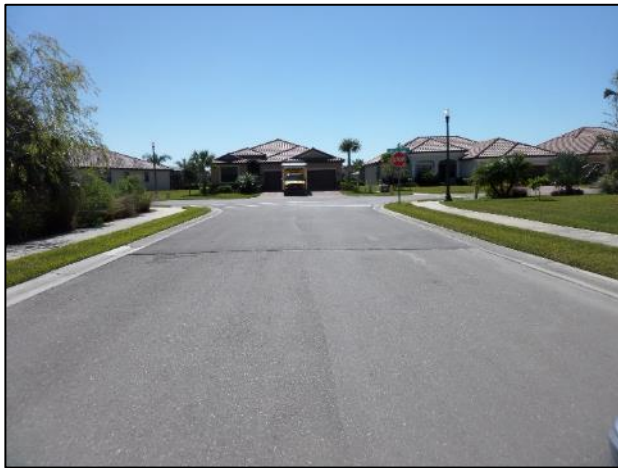
Typical asphalt surface – north area

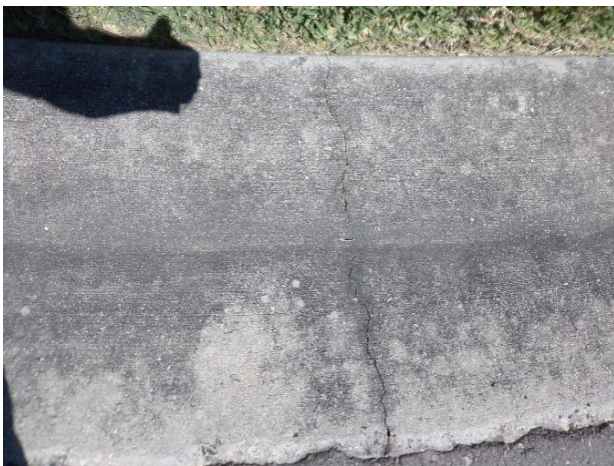
Gutter stain/chips at north area

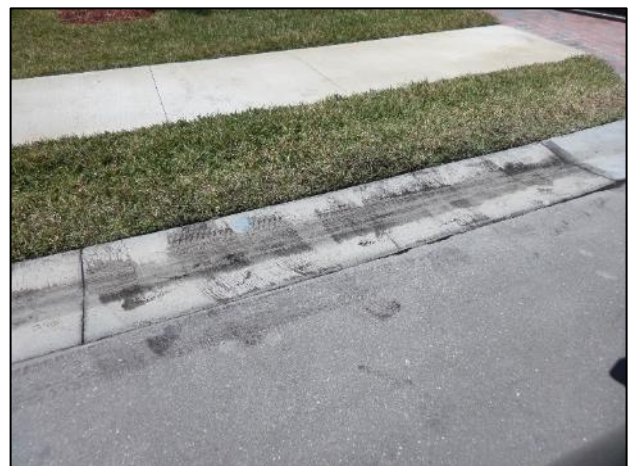
Gutter stains at north area

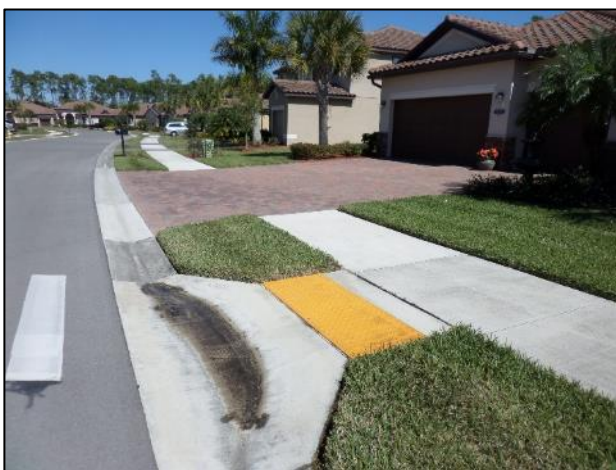
Stains on concrete walkway – north area

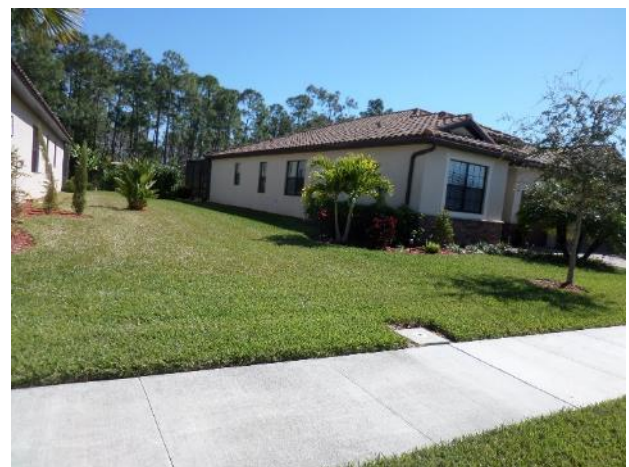
Stains on concrete sidewalk – north area

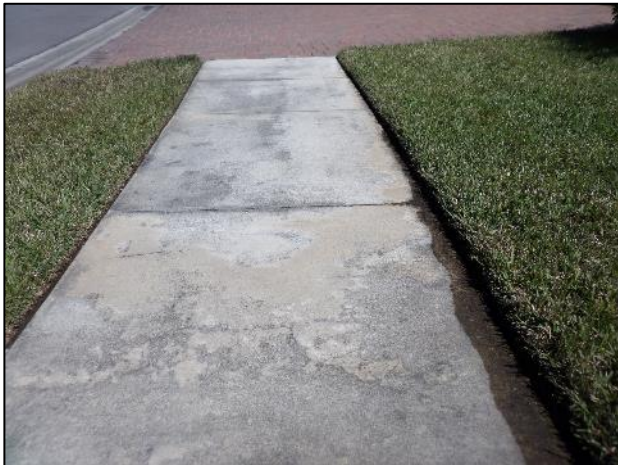
Stains on concrete sidewalk - south area

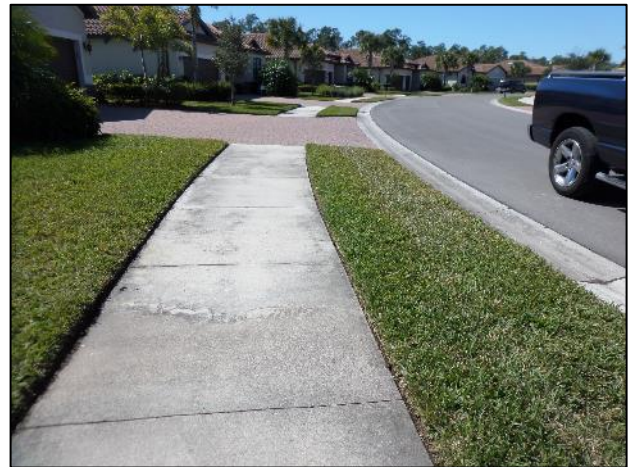
Stains on concrete sidewalk - south area

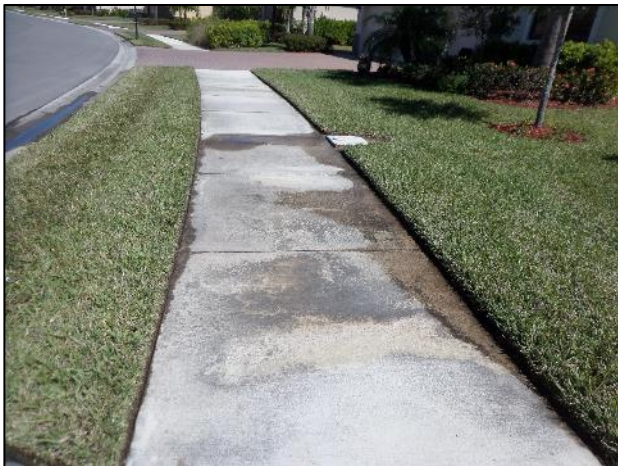
Stains/standing water on concrete sidewalk

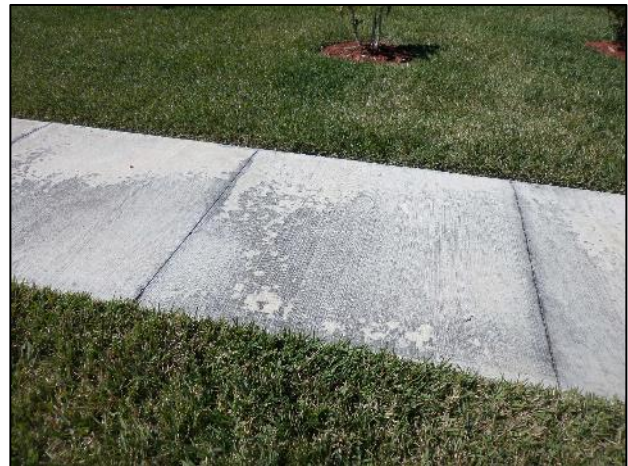
Stains on concrete sidewalk - south area

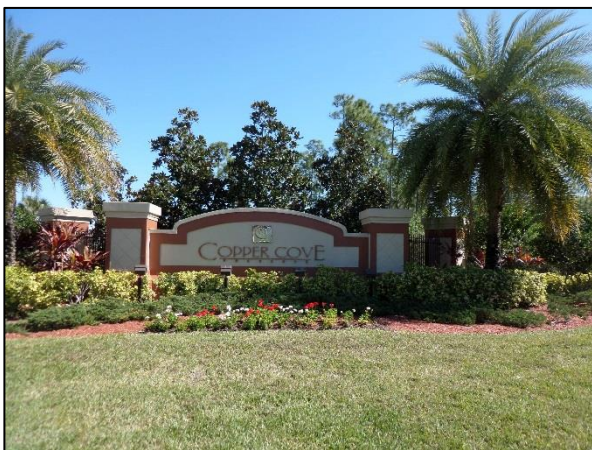
Observed Deficiencies and Recommended Remedies: The main entrance sign, gate and columns are in generally good condition. However, the central icon decal has deteriorated and should be replaced. Portions of the decorative metal fencing have oxidized. The current coating of the fencing should be stripped off and the oxidation removed. It should then be primed and coated with an Ultra High Performance coating system with a 10-15 year warranty. The sign should be inspected and pressure-washed on an annual basis. The stucco elements should be re-painted every seven years.

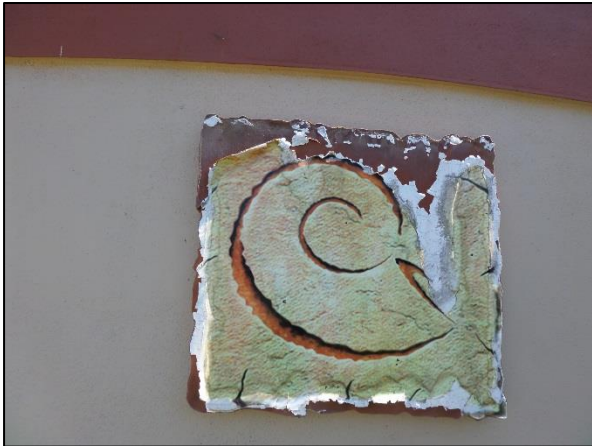
Main entrance sign decal deterioration

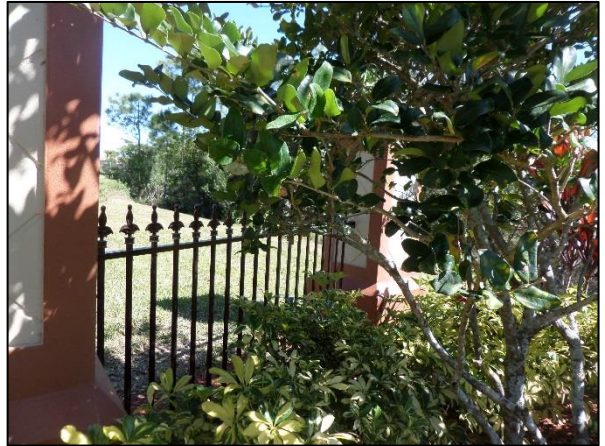
Main entrance sign decorative fence

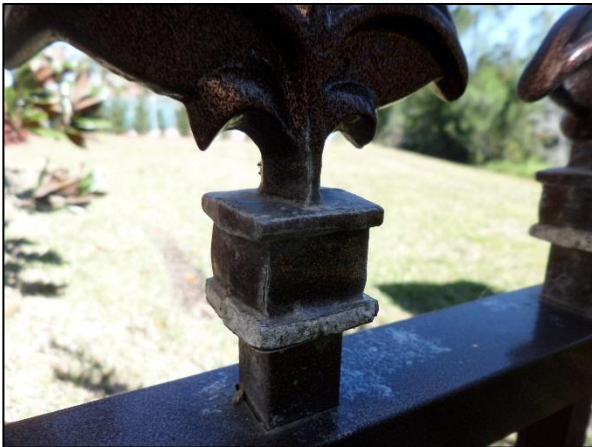
Deterioration/oxidation at decorative fence

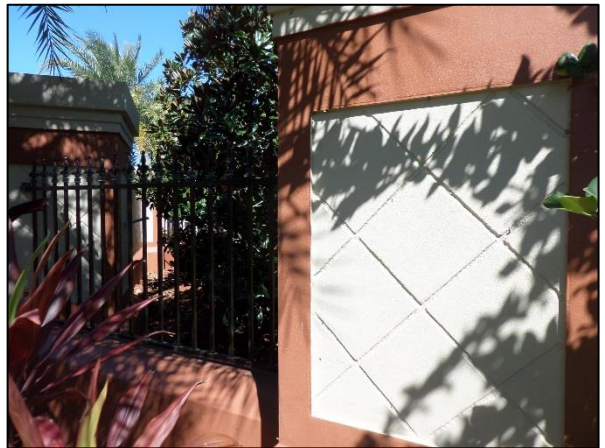
Decorative fence at columns

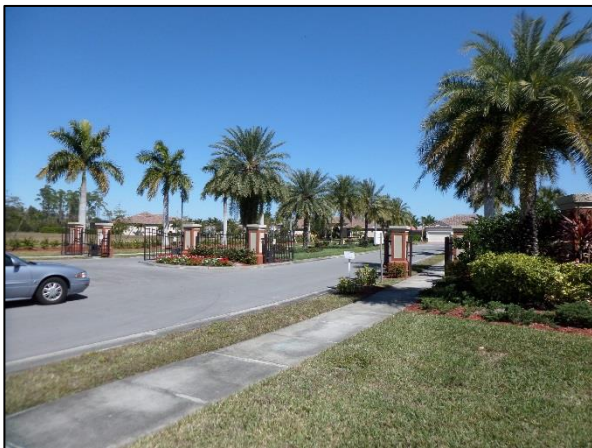
Observed Deficiencies and Recommended Remedies: The main entrance gate could not be tested as they have reportedly not worked since they were installed. At the time of our inspection, the mechanical systems of the gates were reportedly scheduled to be completely refurbished.

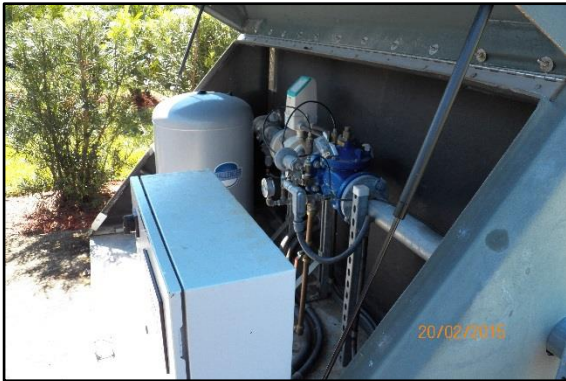
Dry components of the pump station

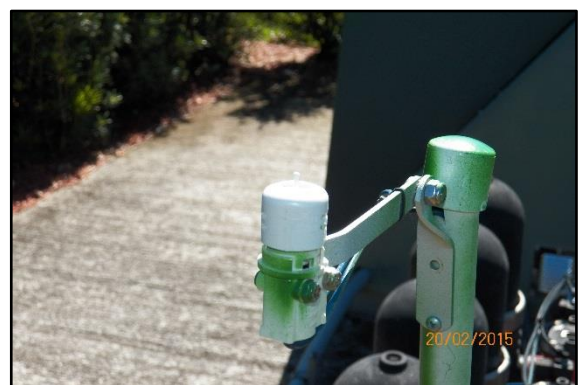
Mini Click Moisture Sensor

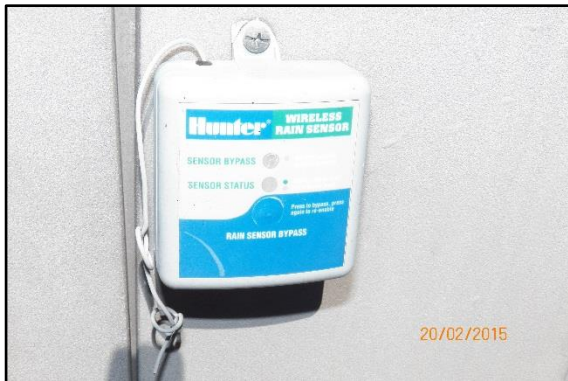
Hunter Remote Rain Sensor Receiver

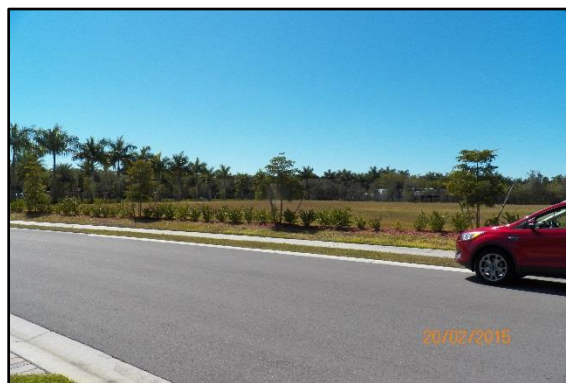
Observed Deficiencies and Recommended Remedies: No observed deficiencies. In communities such as this, landscape will often begin to outgrow its environment and begin to encroach on structures such as sidewalks, pavement and buildings within 20 to 30 yrs. For this reason, it is recommended that when the original landscaping reaches 20 years of age, the association should plan to begin a program of generational replacement over a period of 10 years.

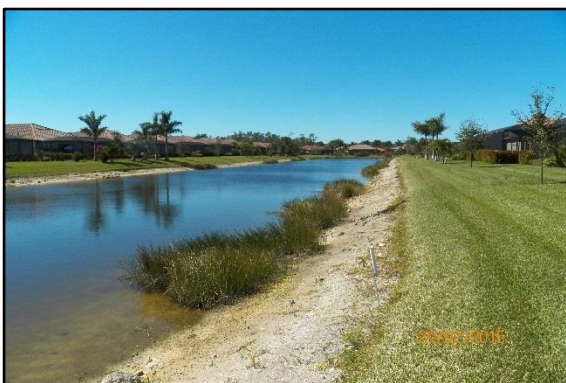
Herbaceous Emergent Littoral Vegetation

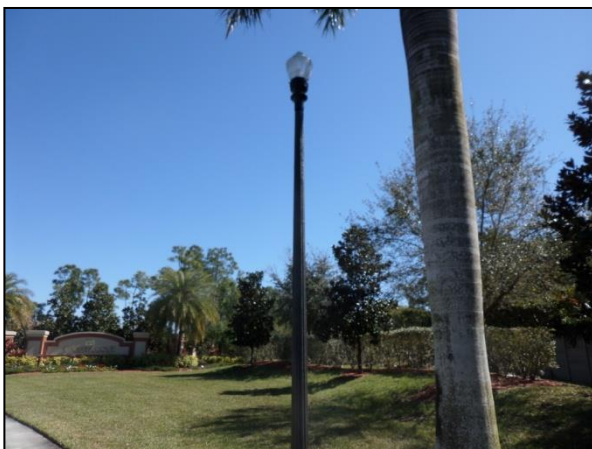
Observed Deficiencies and Recommended Remedies: The lamp posts were observed to be in good condition, with evidence of light wear and tear, with sporadic paint chips. Road signs were in generally good condition. Lamp posts should be cleaned annually and repainted every seven years.

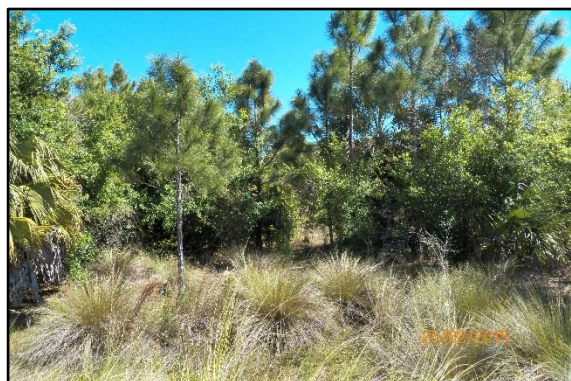
Clean Preserve and Buffer

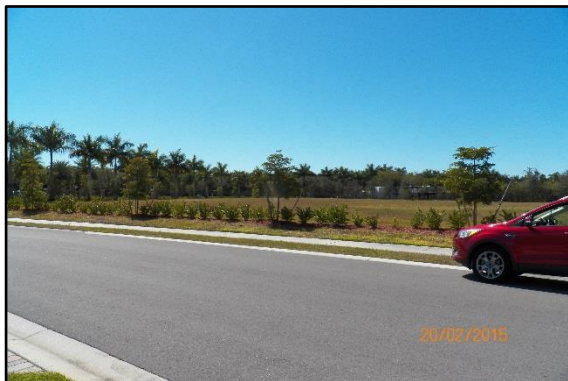
Observed Deficiencies and Recommended Remedies: No deficiencies were observed.

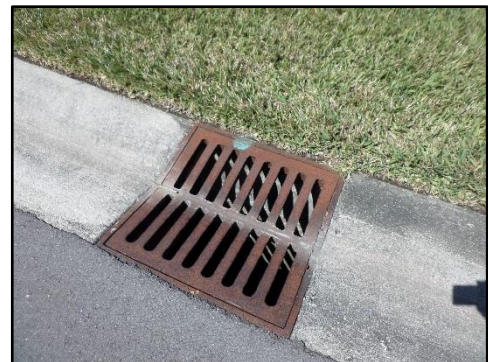
Storm Grate In Good condition
